# Manhole Inspection Summary

Manhole # S29UU\_005MH

Insp Date: **5/16/07 9:10 AM**

**Location** Address: **2902 KESWICK RD**

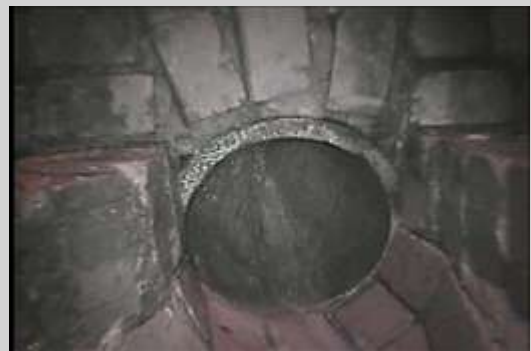
### Drop In @ 3 O'Clock

Drop: **Outside** Rod and Bar

Angled: **Yes** Reading: **10.25** (ft.)

Drop Condition: **Open**
